AS/RS Life-Cycle Upgrades

SRM Floor Rail Upkeep

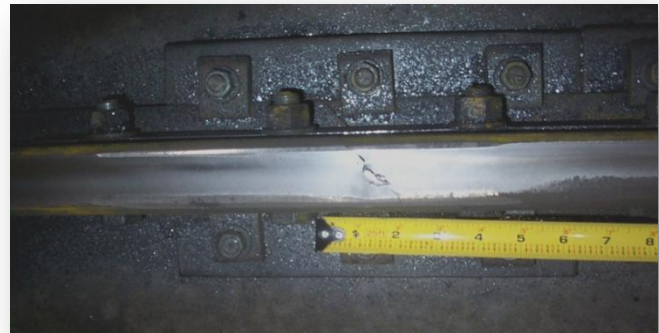
Problem: After several years of operation the AS/RS floor rail is becoming flattened (loss of crown) and has several damaged spots. The Storage/Retrieval Machine (SRM) experiences bumps at floor rail joints and slight jogs during travel. Anchors have become loose and will occasionally be sheared off.

- Subtle bumps and chips in the floor rail surface inflict extreme forces day-after-day to the SRM structural joints and mechanical assemblies. Bumps are caused by mechanical rail splices or unmaintained wear patterns at welded joints (thermite welded joints over time wear less than the parent rail). Floor rail chips and damage can be caused by poor SRM alignment, prolonged operation on failed bearings, damaged wheels and sudden Estops.

Flat and Damaged AS/RS Floor Rail Splice Joint

Solution: Periodic Floor Rail Grinding and Periodic Maintenance

- Profile grinding is performed to remove irregularities.
- SRM wheel and guide roller assemblies are inspected and recommendations for repairs are reported.

- Short sections with severe damage may be cropped, removed, replaced with new, and welded using a specialized thermite welding procedure for an extra fee. In some cases, little used sections at the back of the aisle have been swapped with worn sections at the front of the aisle.

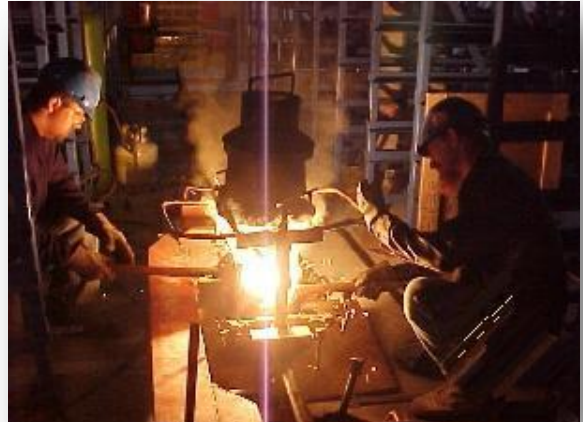
Thermite Welding AS/RS Rail Repair Procedure

- The aisle is surveyed for profile and alignment.
 - The old floor rail is removed and the new rail is installed. Thermite welding procedures may be performed outdoors or inside the AS/RS aisle.
